High Strength Polymeric Geocell-Reinforced Railway Line Repair in Degraded Permafrost Condition

Sanat Pokharel, Ph.D., P.Eng.¹ and Marc Breault²

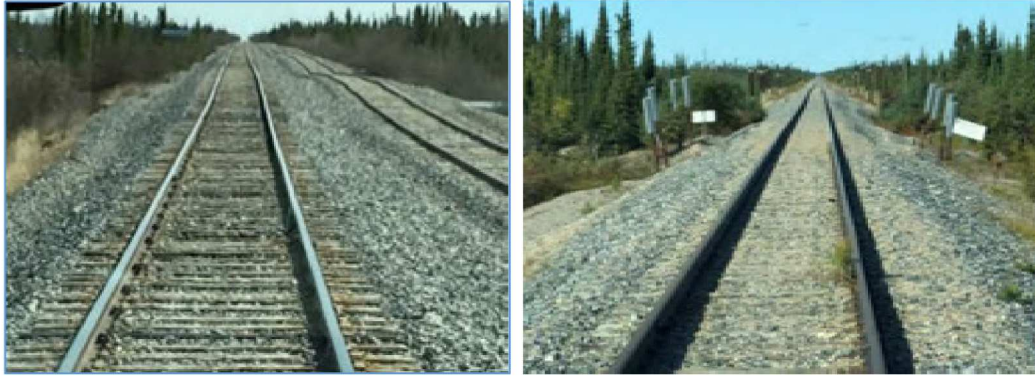
Figure 1. The condition of railway line in May 2016.

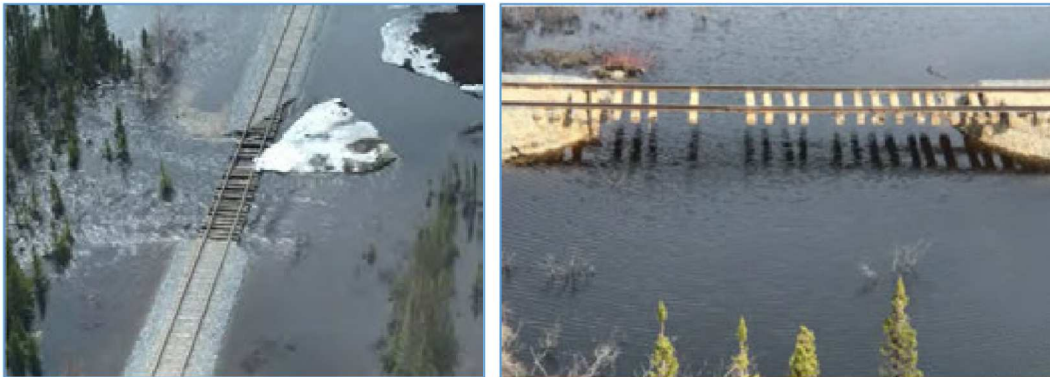
Figure 2. The railway line during the flood in 2017, aerial view. (Global News, 2017)

permafrost and the erosion control at almost all the stream crossings. The pictures in Figures 2 and 3 show the extent of devastation. The design for rehabilitating this railway line needed to address multiple issues that included structural strength, erosion control, protecting the already degraded permafrost from further degradation and most importantly, utilizing the washed-out material deposited at and around the washout locations. If the material was not enough it would have needed to bring virgin aggregate but still it would have been a low quality 75mm minus pit run gravel from Gillam (about 200km to 250km south). It should be noted here that the only access to the site was the railway line itself. Given the timeline of 6 weeks which seemed impossible for any other options thought of at the time because there were more than 26 damage locations along 150km stretch in series.

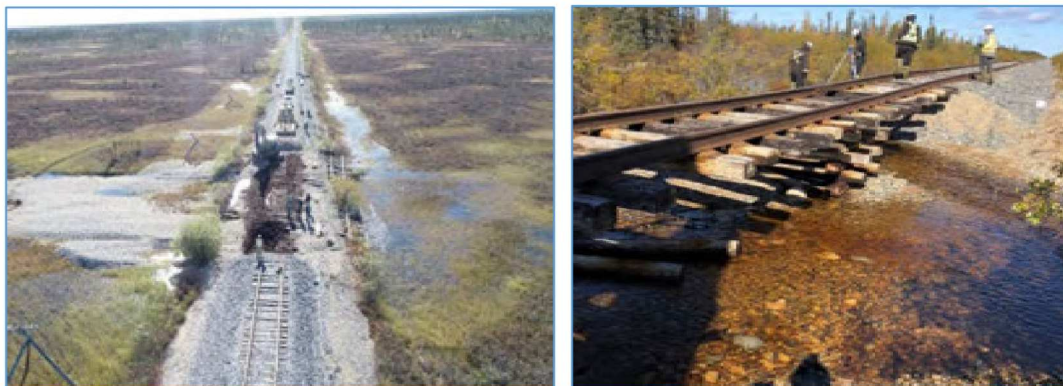
Figure 3. The condition of railway line after the flood event pictures from 2018.

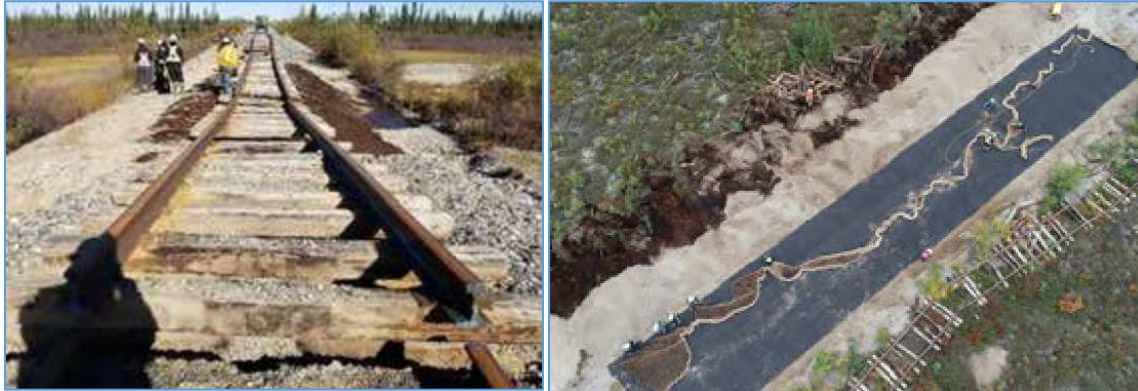
Figure 5. The track removal for the repair works

Geocell was stretched and installed at the site with guide stakes. The requirement of more than one layer of the Geocell was decided at the site wherever there was more than 750mm fill required between two layers. The railway track was cut and placed aside to allow the installation of geocell and construct the embankment. When the embankment was ready it was lifted back to the position and connected.

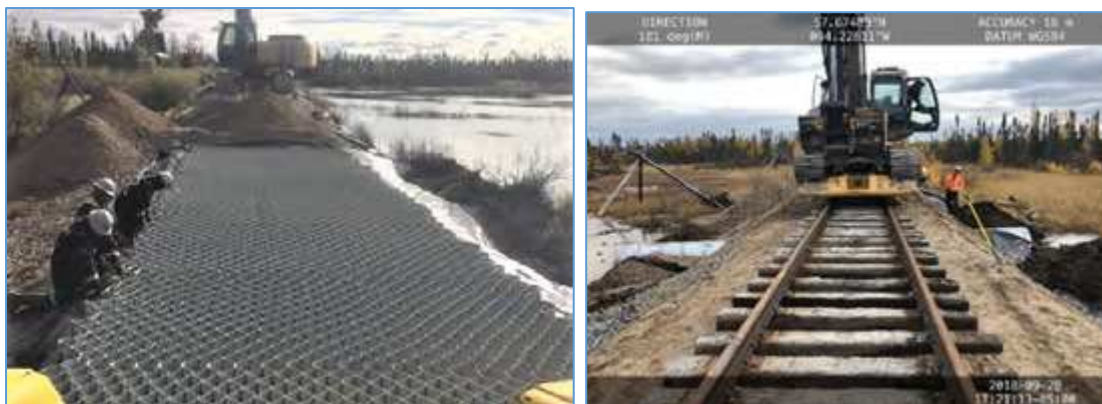
Figure 7. Geocell for sub-ballast reinforcement and section ready for ballast fill

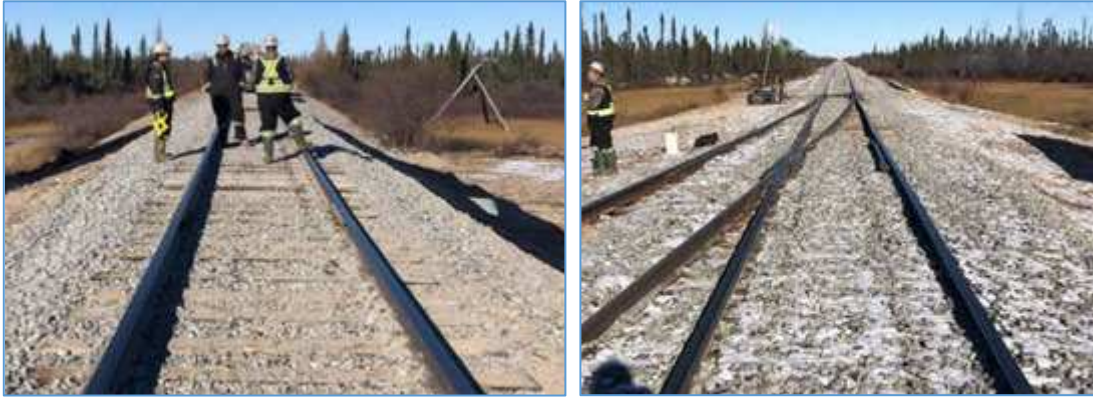
Figure 8. Completed rail re-installation at MP 427 and near switch at MP 414
